TRAFFIC SAFETY STUDY

ACCIDENT LOCATIONS

CASCADE COUNTY, MONTANA

DEPARTMENT OF JUSTICE CONTRACT NO. 89-06-02-1

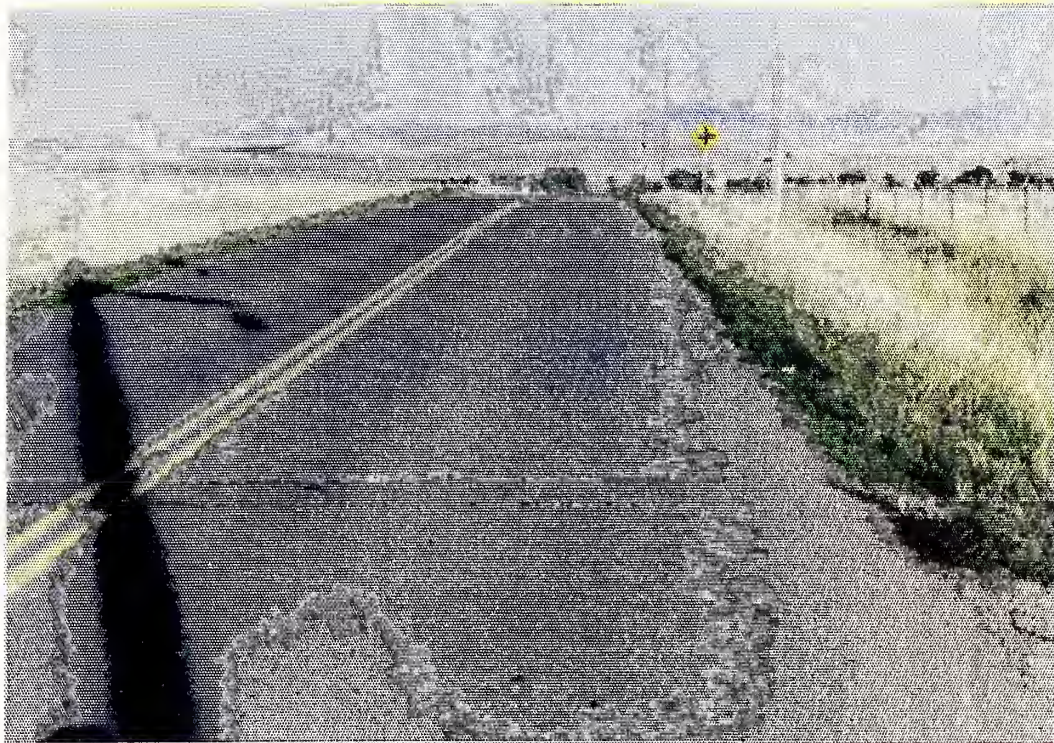
SITE 3: On Gibson Flats Road at approximately 0.1 miles west of the intersection with 26th St. S looking east. (1/10)

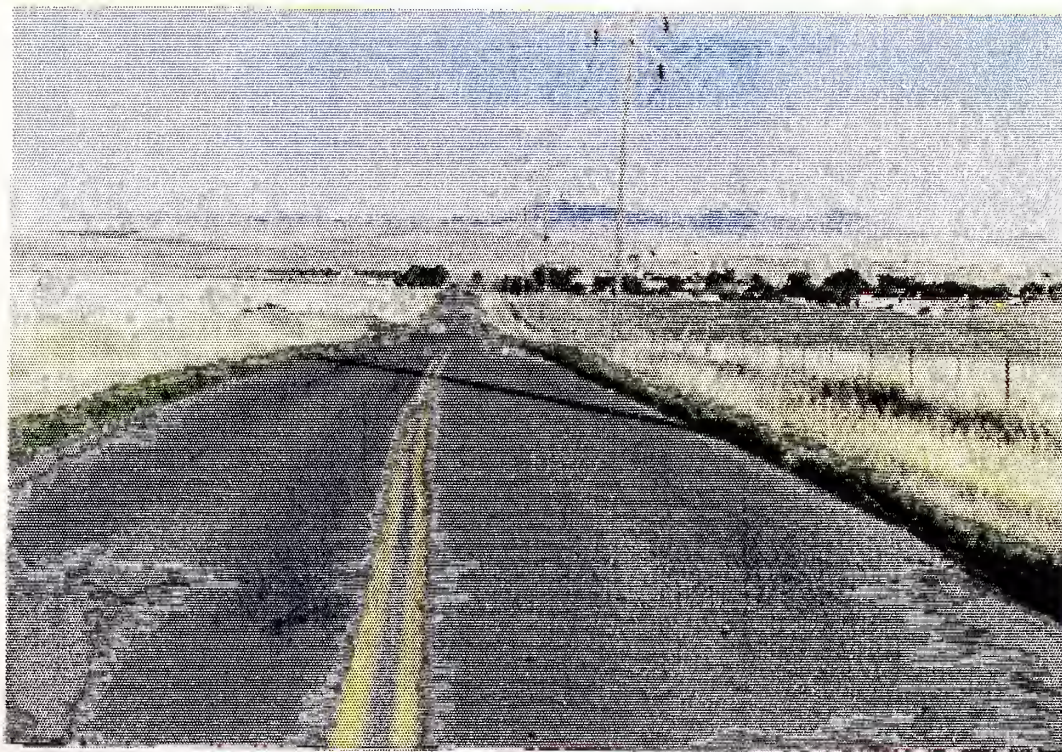
SITE 3: Taken on Gibson Flats Road approximately 400' west of 26th St. S (adjacent to the intersection ahead sign) looking east. (1/11)

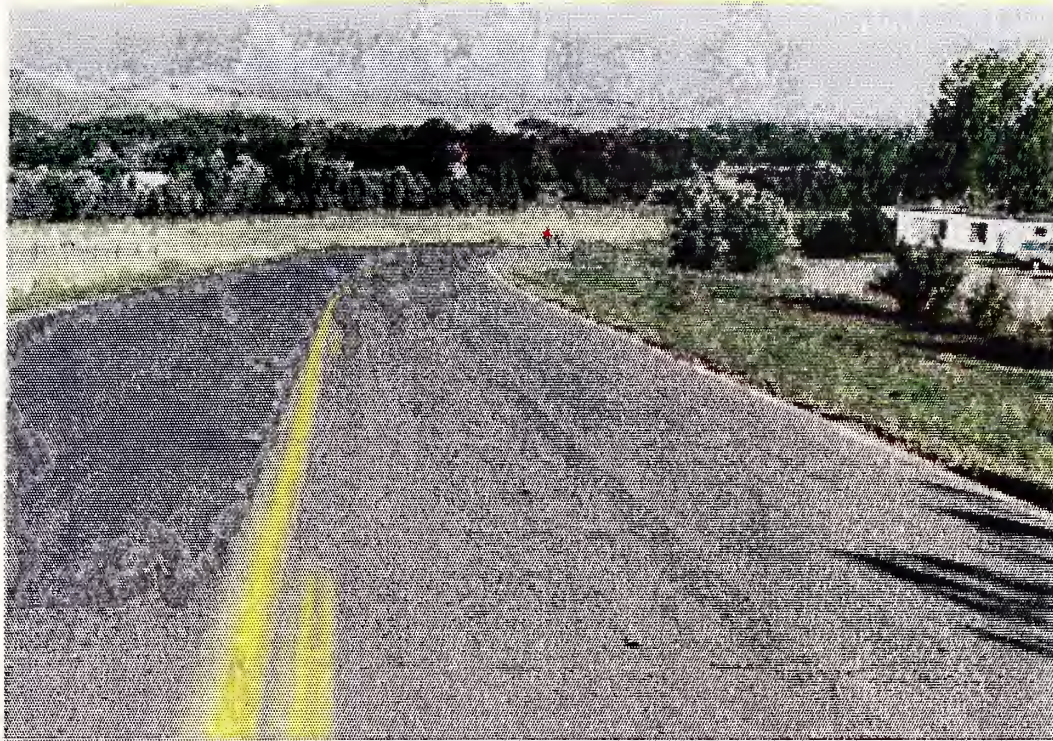
SITE 4: Approximately .25 miles south of Trailer Terrace on Lower River Road looking north. (3/15)

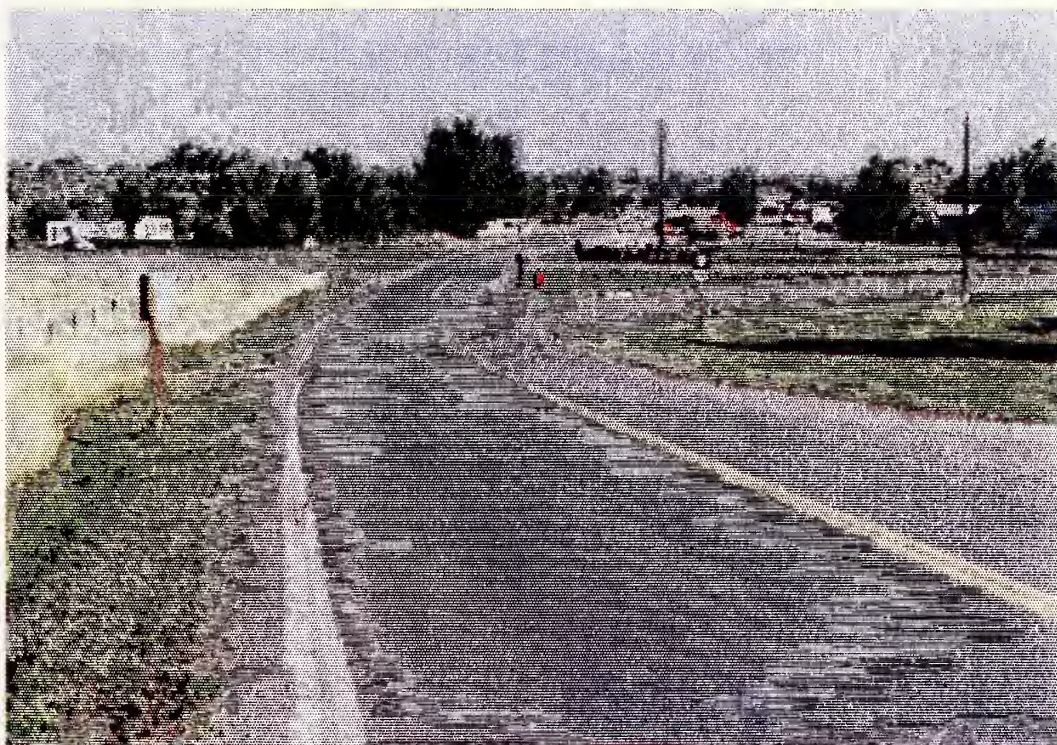
SITE 4: On Lower River Road 400' south of Trailer Terrace looking north. (3/18)

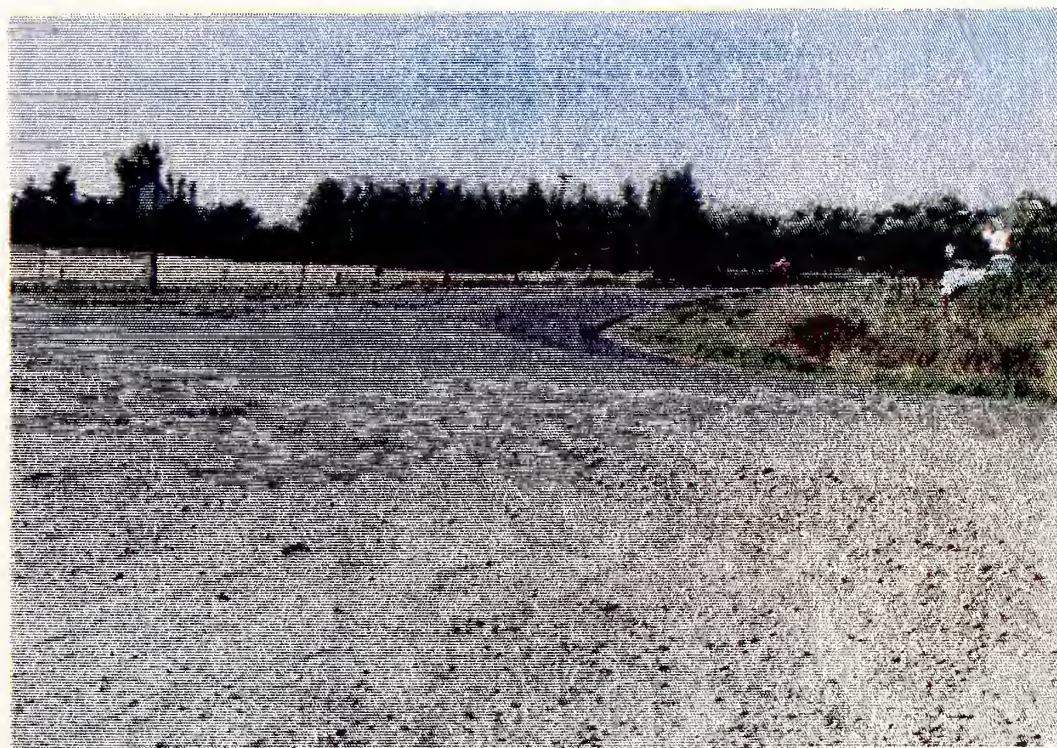
SITE 4: From the northeast quadrant of the intersection, at the south convenience store drive approach on the east side of Lower River Road, looking southwest down Wilson Butte Road. (3/23)

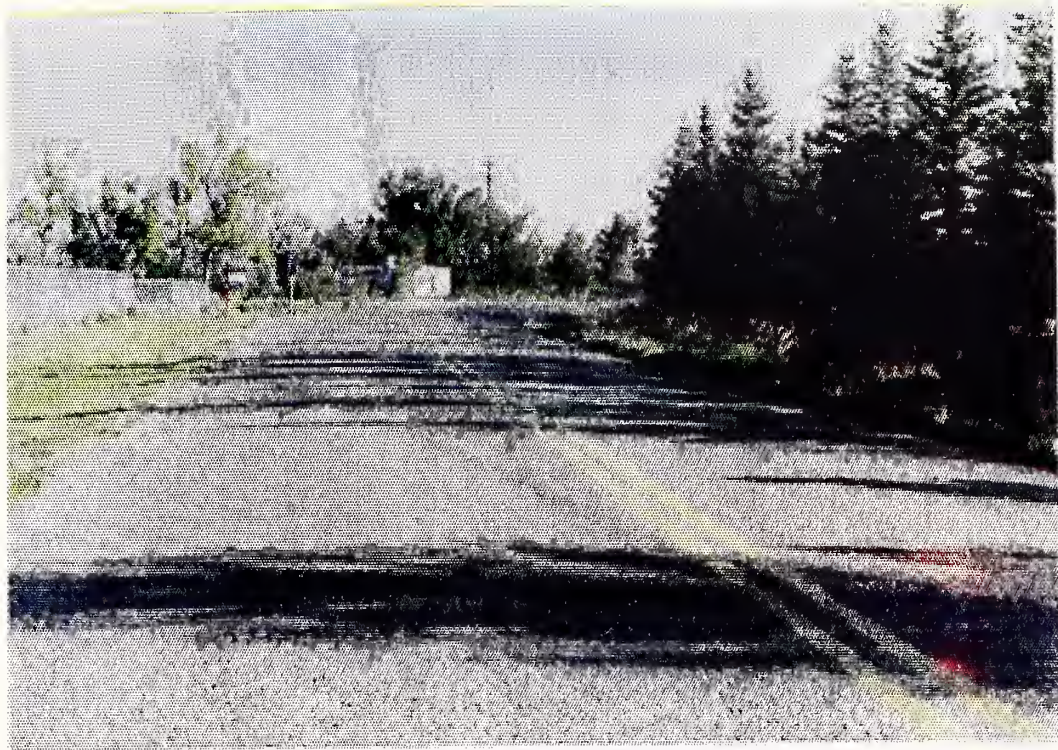
SITE 4: On Wilson Butte Road from around the curve approximately 750' in advance of Lower River Road. Note the intersection is not visible from this location. (4/1)

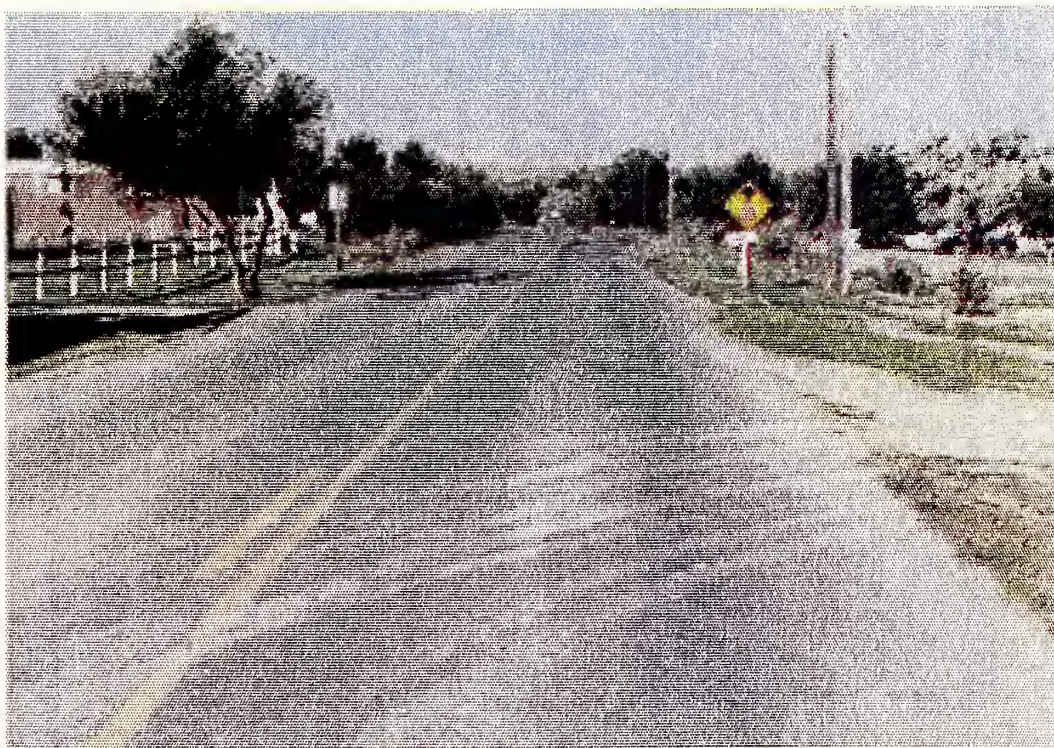
SITE 4: On Trailer Terrace approximately 750' east of Lower River Road looking west. Note the two pedestrians on the left side of the photo at the intersection. The W3-1a "Stop Sign Ahead" sign is faded. (4/2)

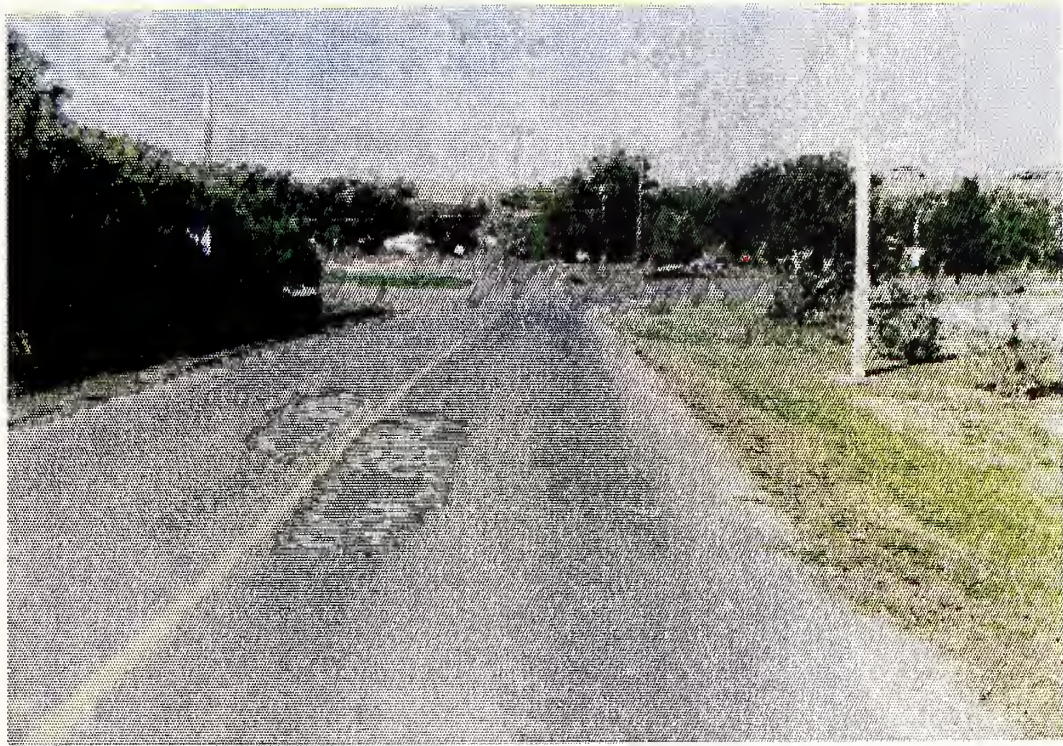
SITE 4: On Trailer Terrace approximately 400' east of Lower River Road looking west. Trailer Terrace slopes downward into the intersection at this location. (4/3)

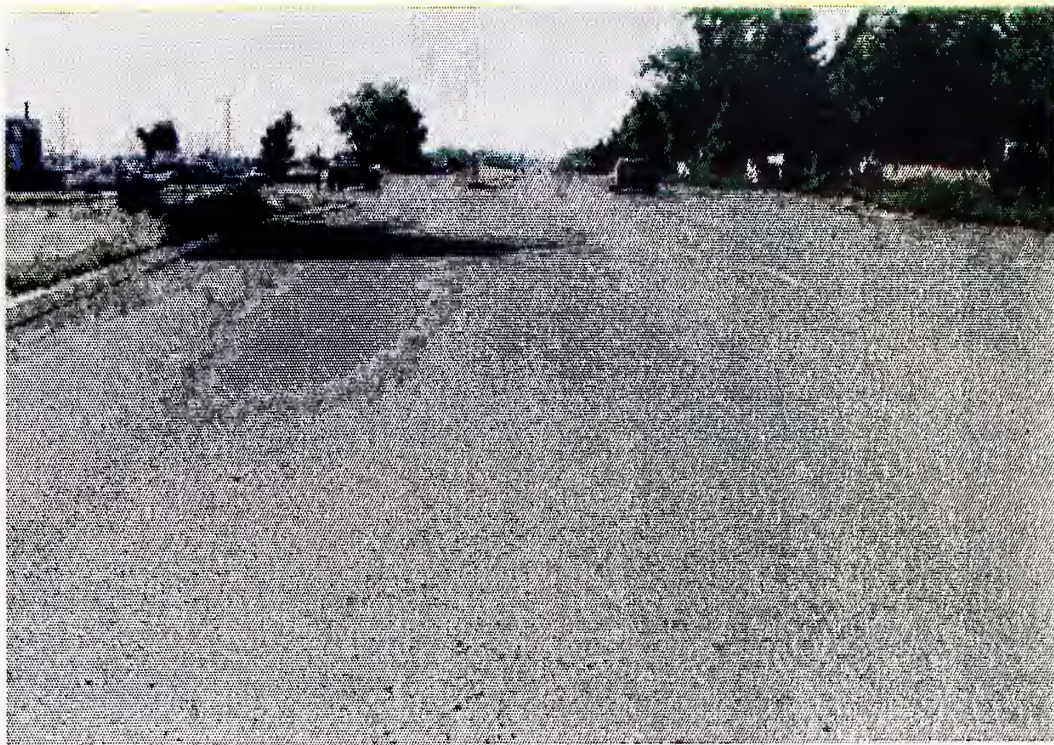
SITE 5: On 2nd Avenue North approximately 200' east of 58th Street North from the approximate driver eye height. The full signal indication is barely visible to westbound traffic from this location. (2/25)

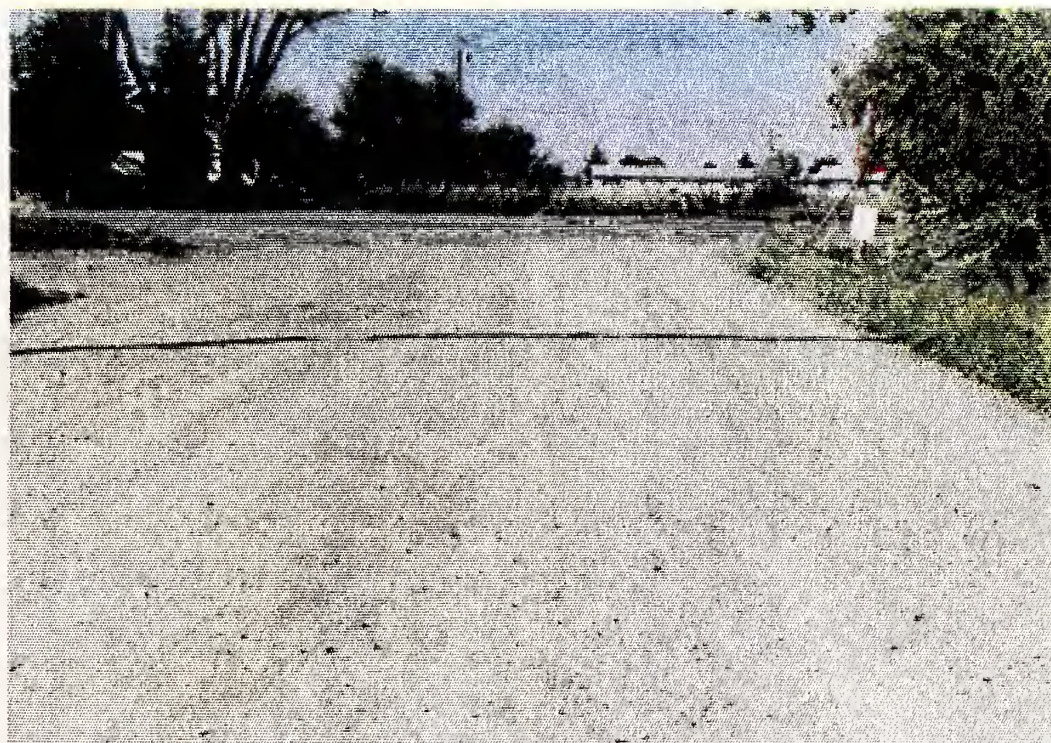
SITE 5: On 58th Street approximately 110' south of 2nd Avenue looking north. Sight distance from the stop bar at 58th Street is good to the east. Sight distance to the west, is approximately 400' to the crest of the hill towards 57th Street. (3/1)

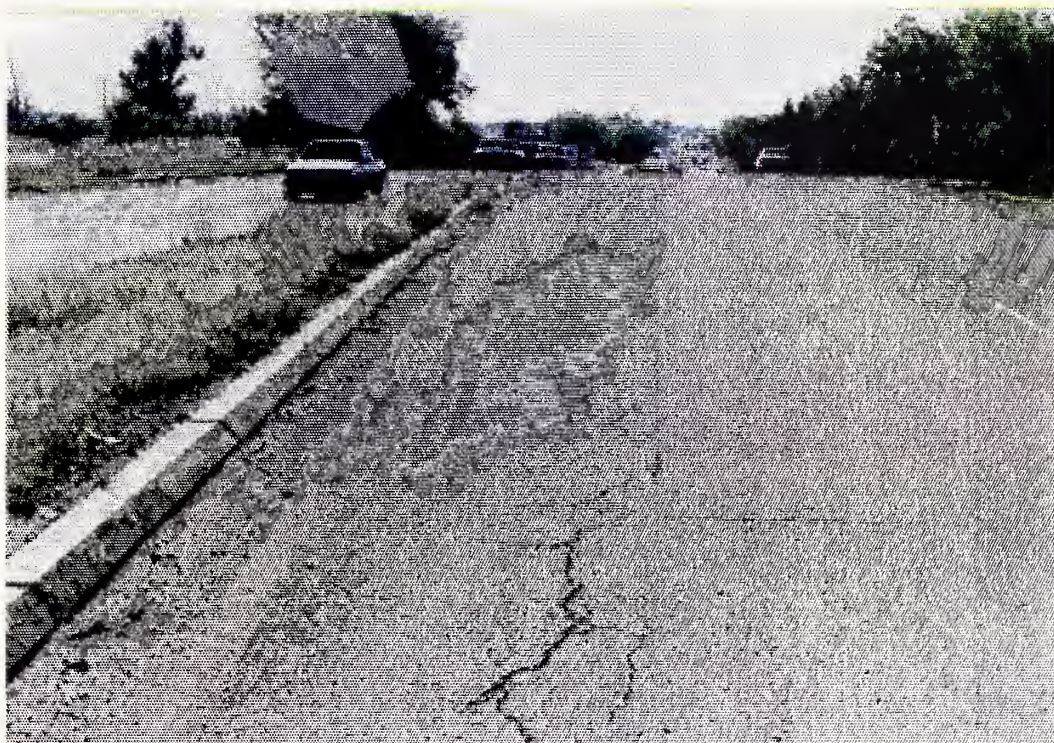
SITE 5: On 2nd Avenue North at the beginning of the first westbound left turn bay taper west of 58th Street looking west at 4:30 PM near the beginning of the peak hour. (3/2)

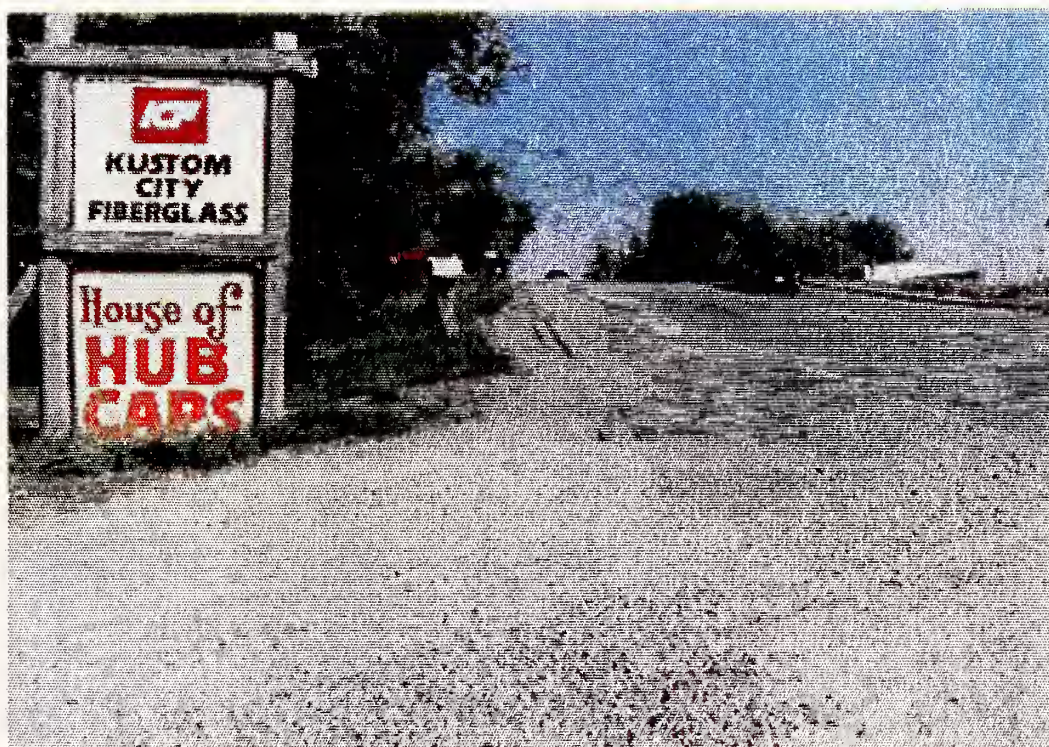
SITE 5: Taken from a gravel approach on the north side of 2nd Avenue North looking east from the approximate drivers eye position. Note the tops of westbound vehicles are just becoming visible. Time 4:41 PM. (3/7)

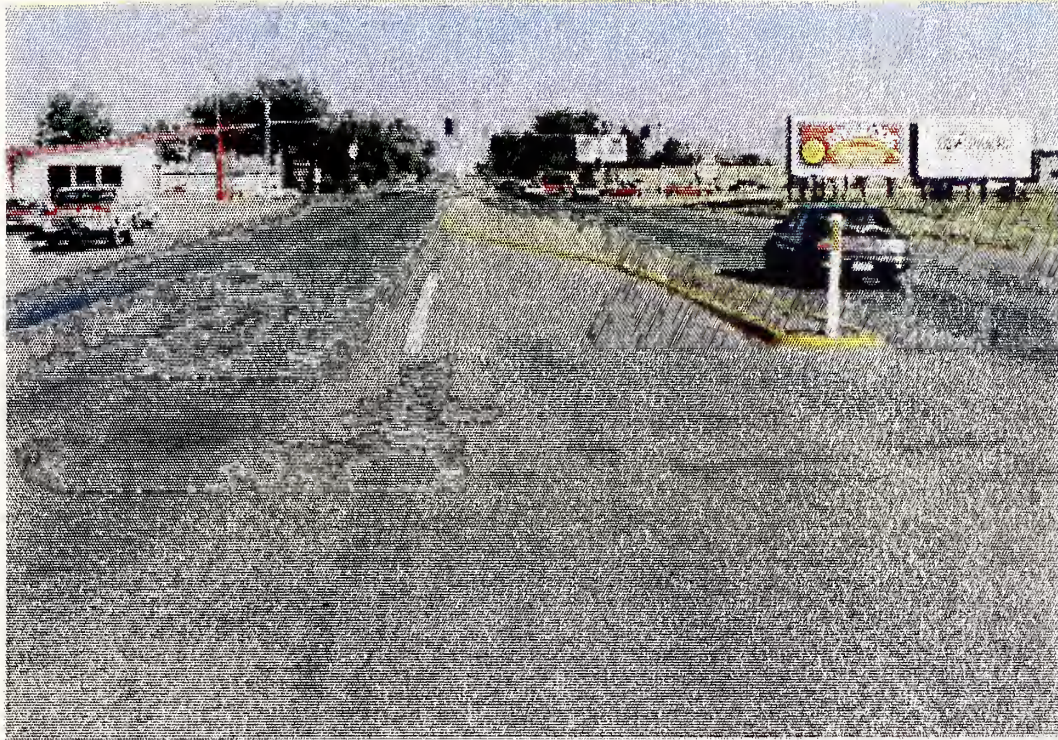
SITE 5: 2nd Avenue North just west of the end of the first break in the median west of 57th Street looking east. Time 5:00 PM. All westbound approach lanes clear on each cycle. (3/11)

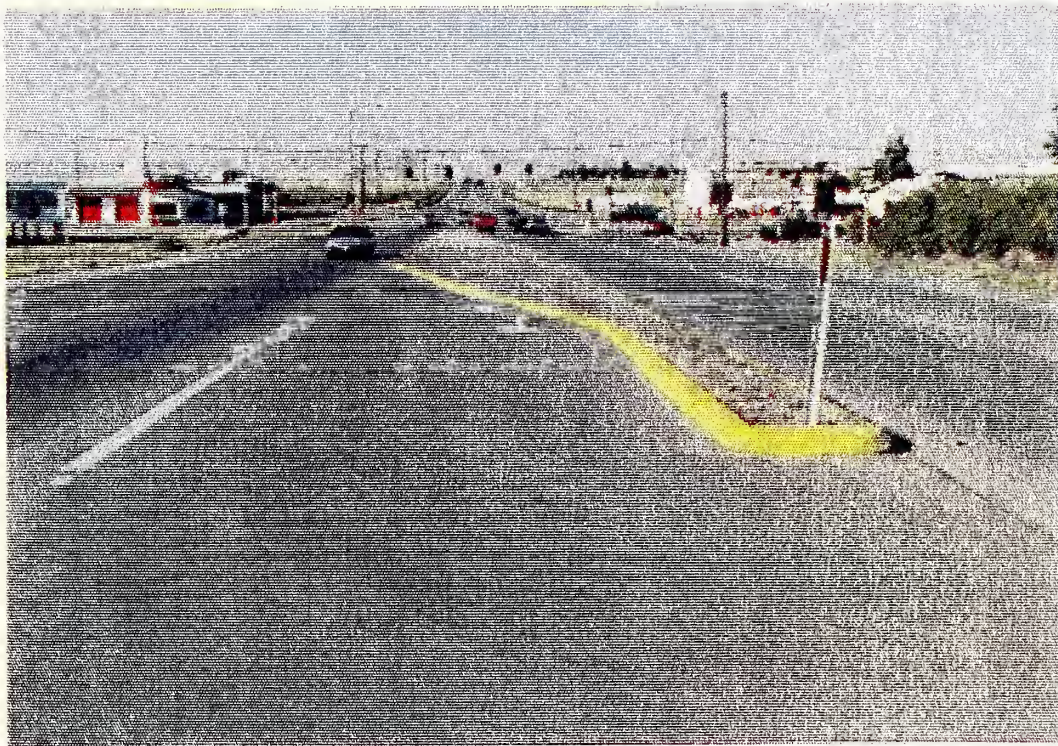
SITE 5: Taken on 57th Street approximately 450' south of 2nd Avenue North looking north. Time 5:06 PM. 57th Street slopes down to the north. (3/13)

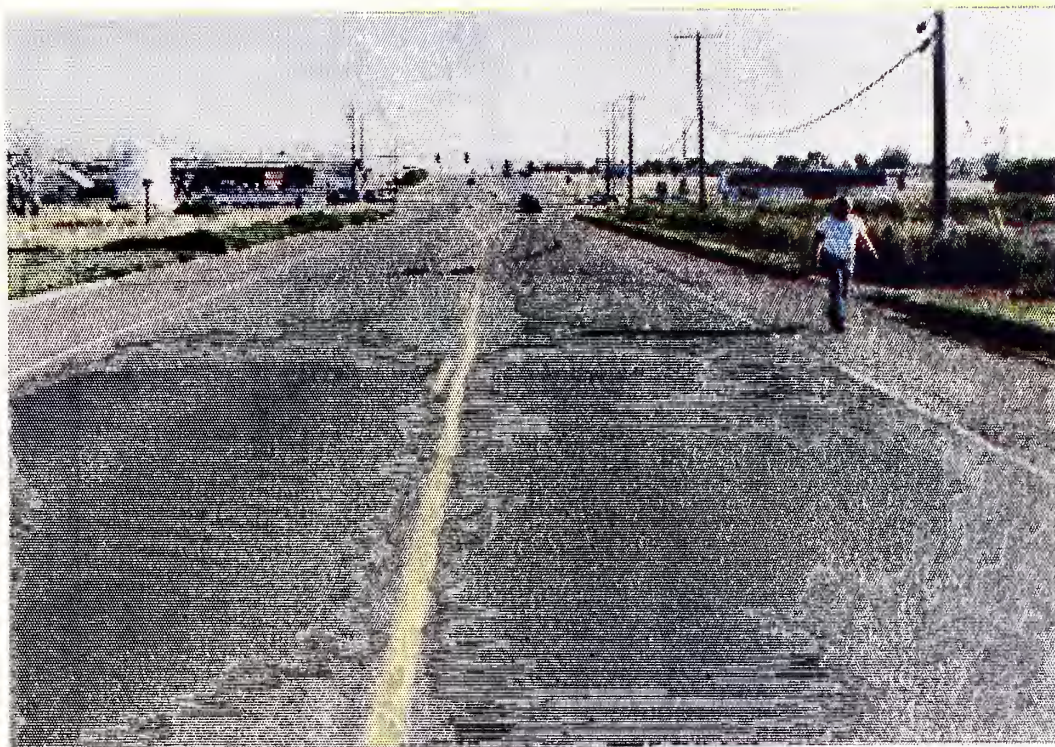
SITE 5: Taken on 57th Street approximately 500' north of 2nd Avenue  
North looking south. (3/14)

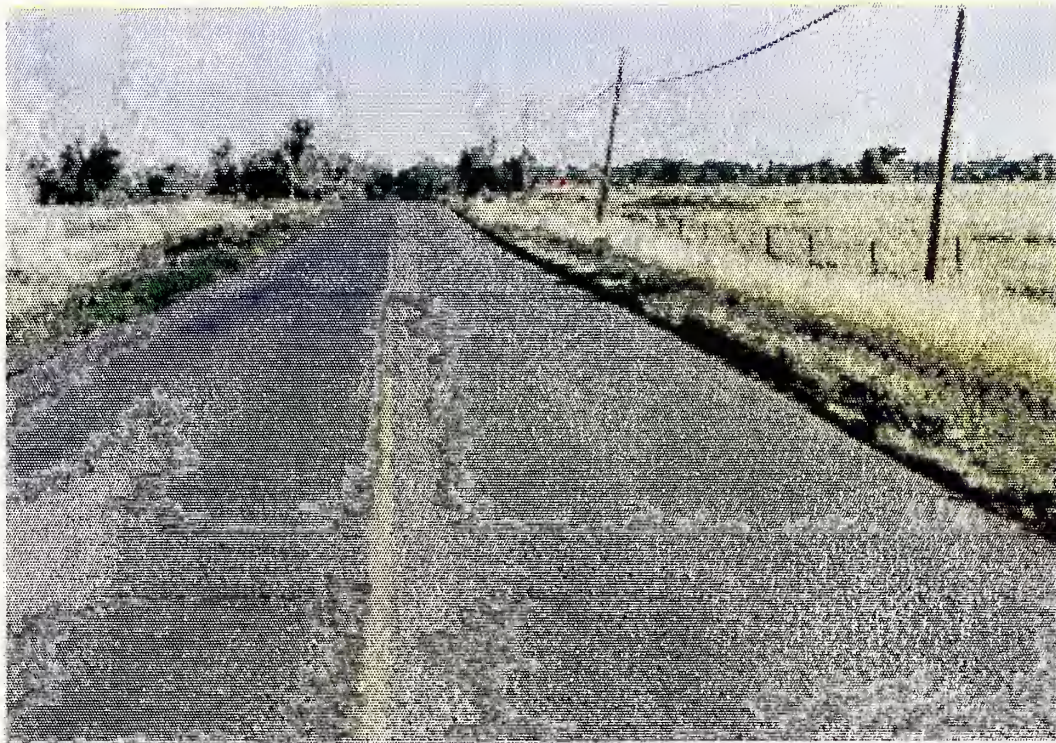
SITE 8: From approximately .25 miles south of 24th Ave. S looking north. The intersection is not visible due to the crest of the hill .15 miles south of the intersection where the suburban is traveling northbound. (0/15)

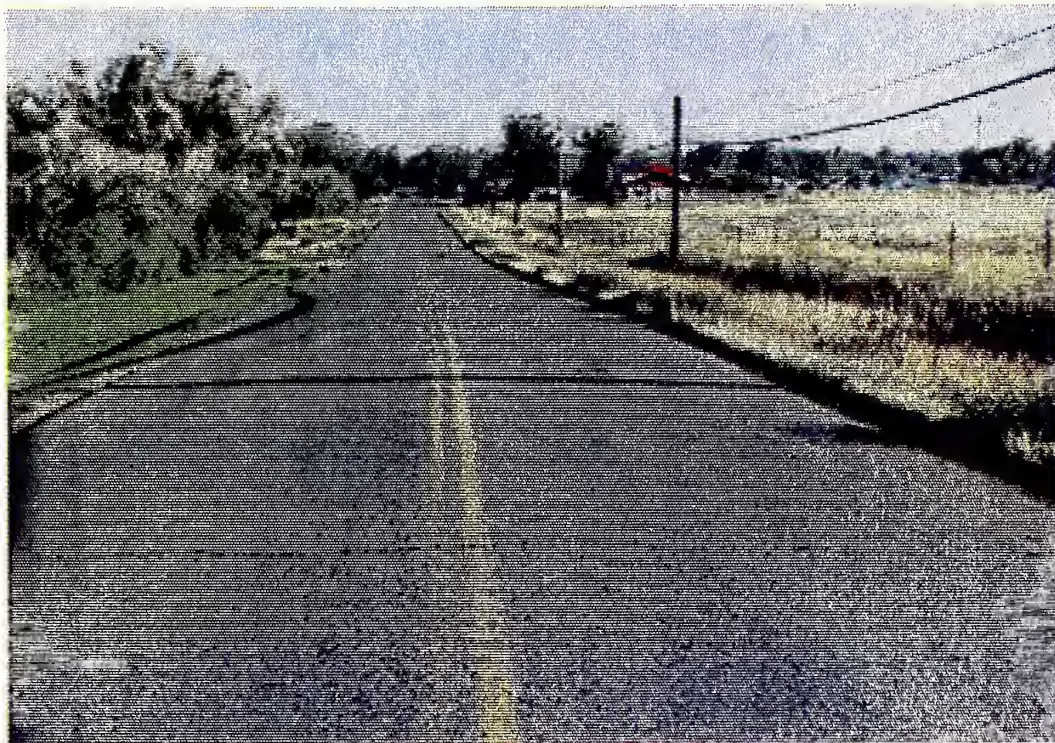
SITE 8: On S. 13th St. 0.15 miles south of the intersection with 24th Ave. S at the crest of the hill looking north. (0/15)

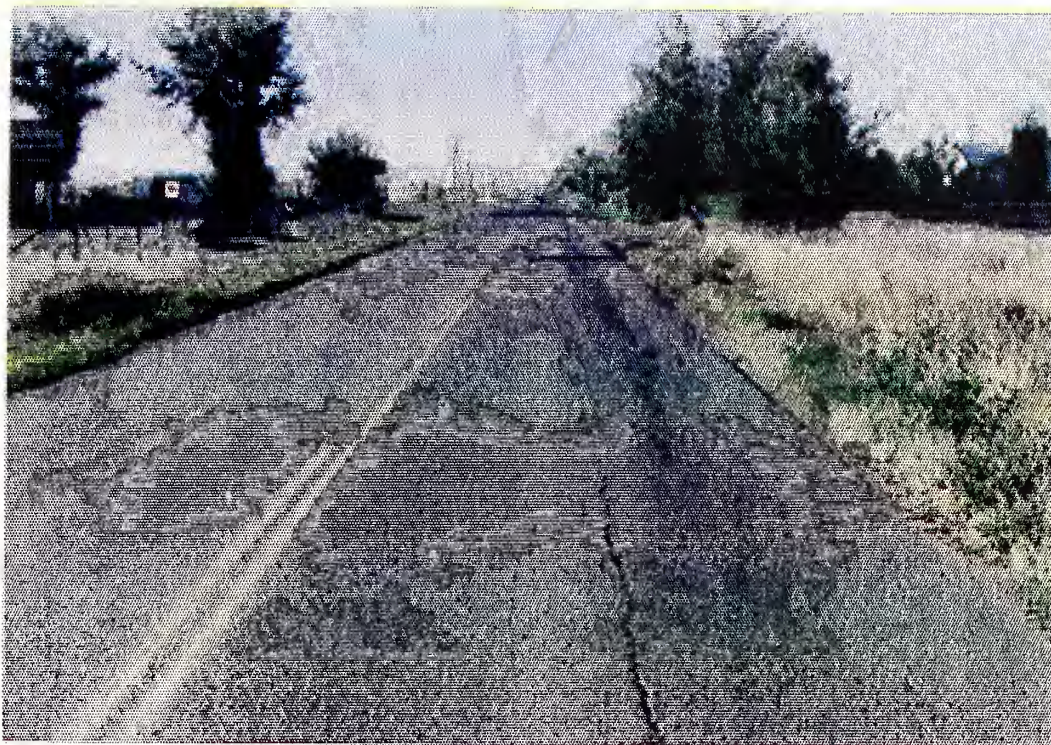
SITE 8: On 13th St. S approximately 0.1 miles north of 24th Ave. S looking south. (0/17)

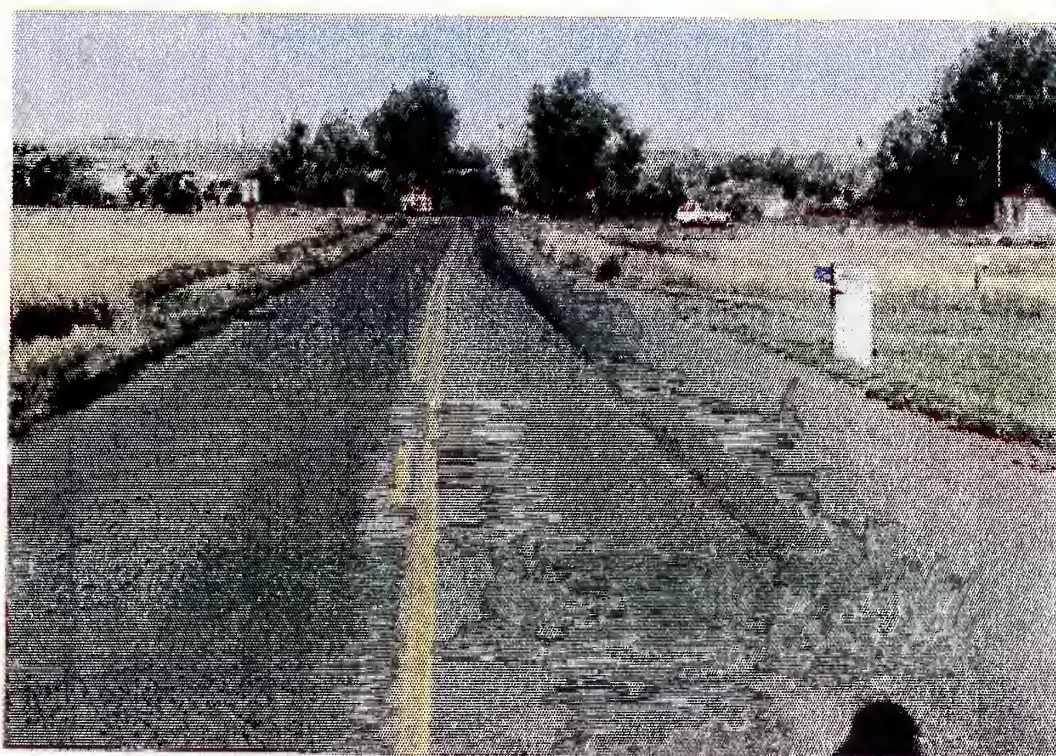
SITE 8: On 24th Ave. S approximately 200'± east of S. 13th St. looking west. The intersection of 24th Ave. S and 15th St. S is approximately 100' east of where this photo was taken. (0/19)

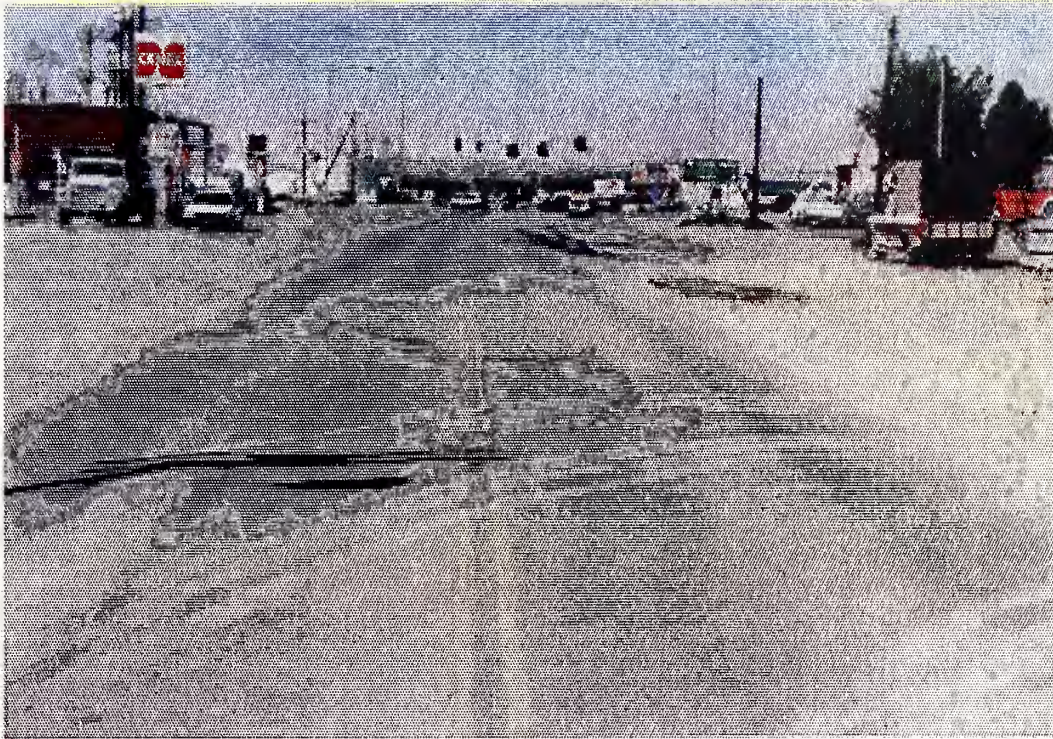
SITE 11: Smelter Avenue from approximately 10th Street looking west. There is a great deal of semi-truck activity on the east leg of the intersection due to; a) North American Van Lines being located at the northwest corner of Smelter Avenue and 11th, and b) North American's semi-truck weigh scale in the southwest corner of their site. (2/6)

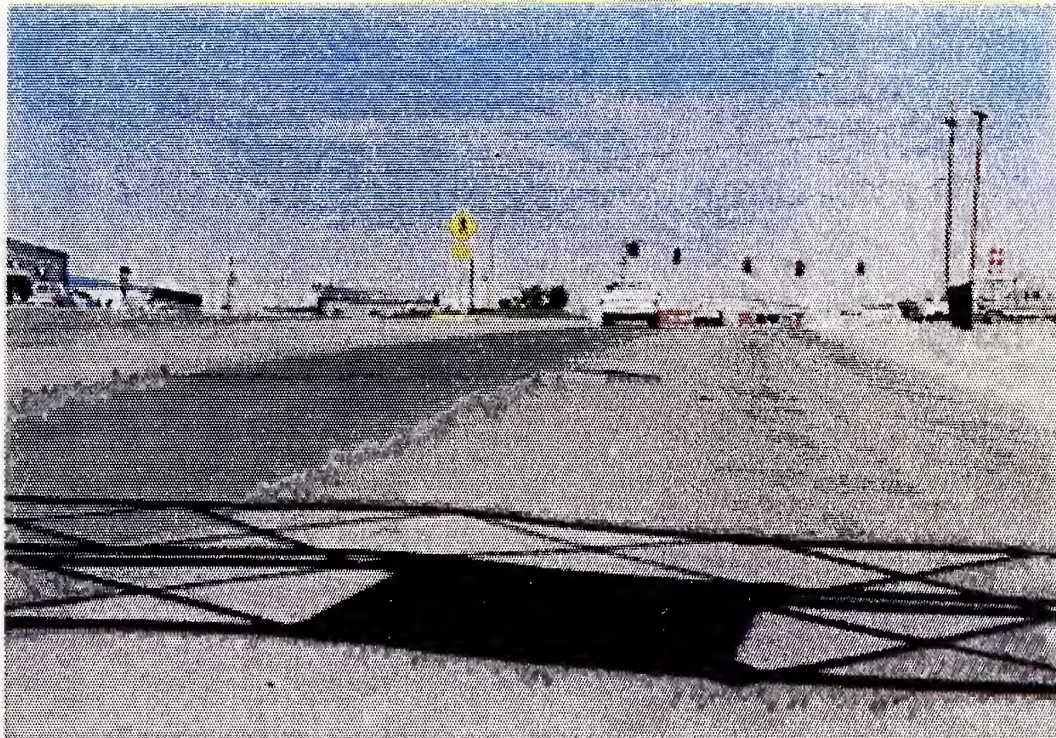
SITE 11: On 10th Street North beneath the overhead sign bridge 500' south of Smelter Avenue looking north. This photo is taken from the driver's eye height in the right outside lane. (2/9)

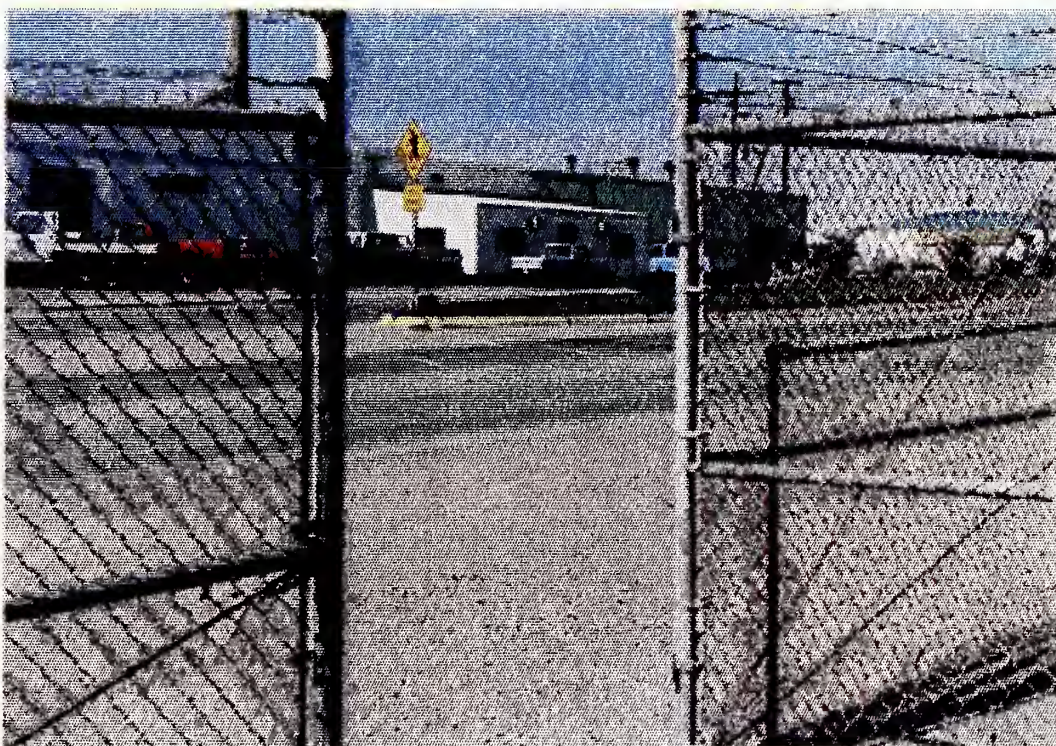
SITE 11: Taken on the south leg of 10th Street North approximately 80' south of the south end of the median looking northwest through the pedestrian gate of the refinery parking lot. This gate is lined up approximately across 10th Street North from the refinery office door. Notice the two types of pedestrian crosswalk striping just south of the median. (2/10)

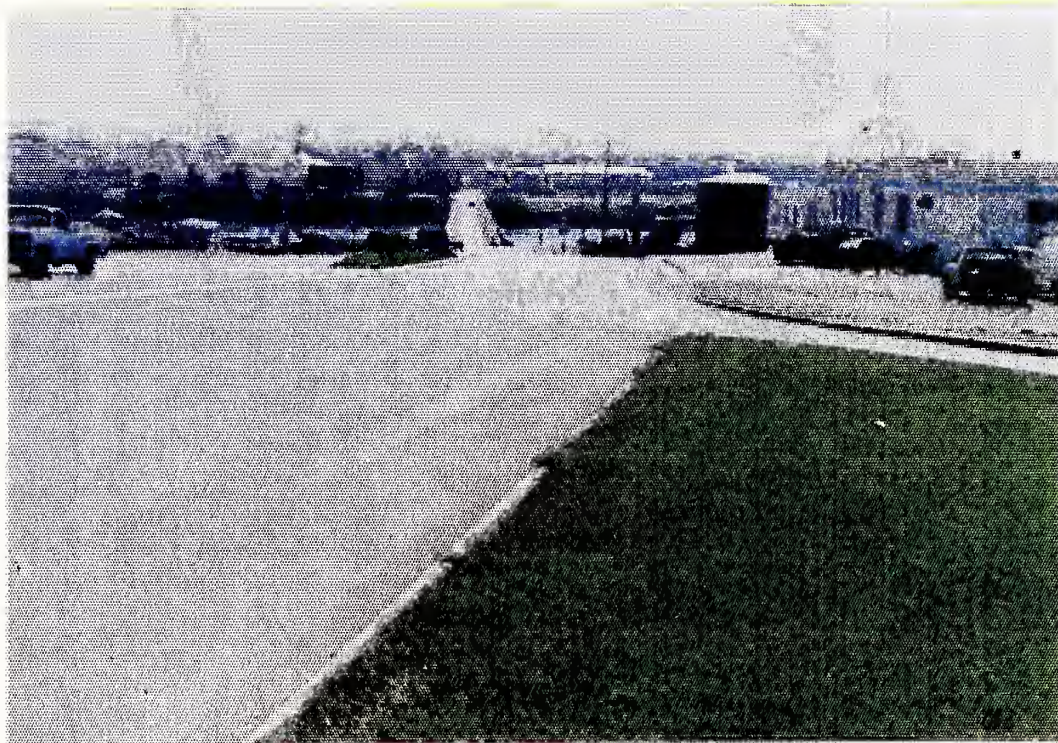
SITE 11: Taken from the landscaped median in the southwest corner of the intersection looking south down 10th Street North. (2/13)

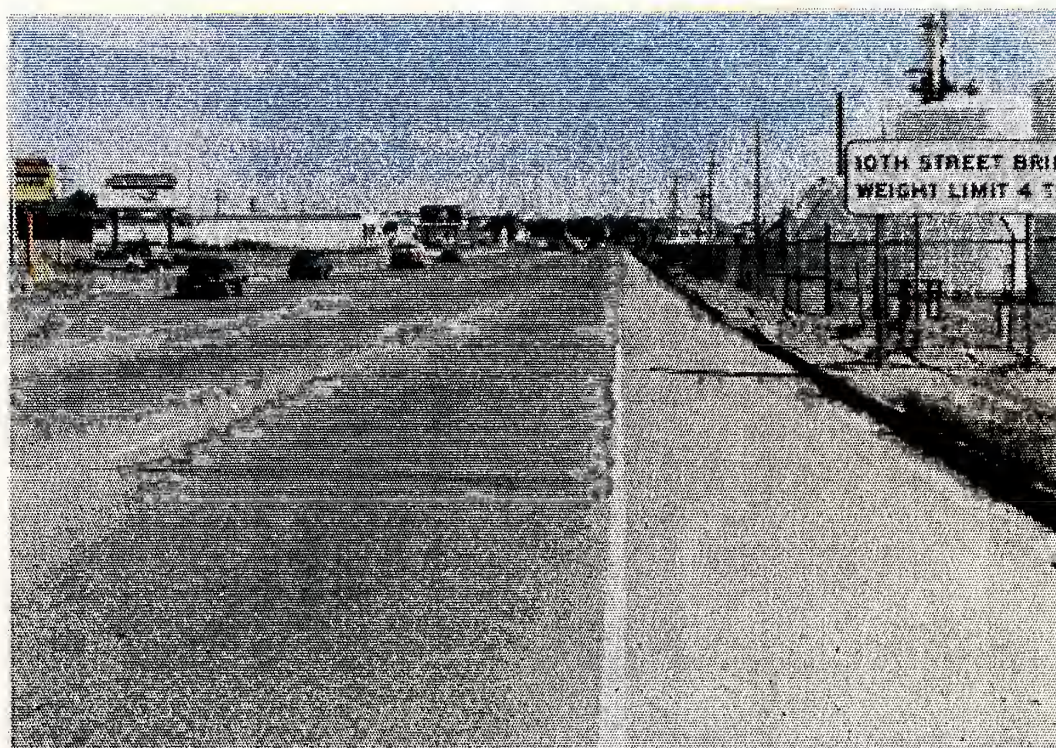
SITE 11: On Smelter Avenue near the 10th Street bridge weight limit 10 tons sign looking east toward Black Eagle. The light pole on the extreme left is on the northeast corner of 8th Street north and Smelter Avenue. (2/14)

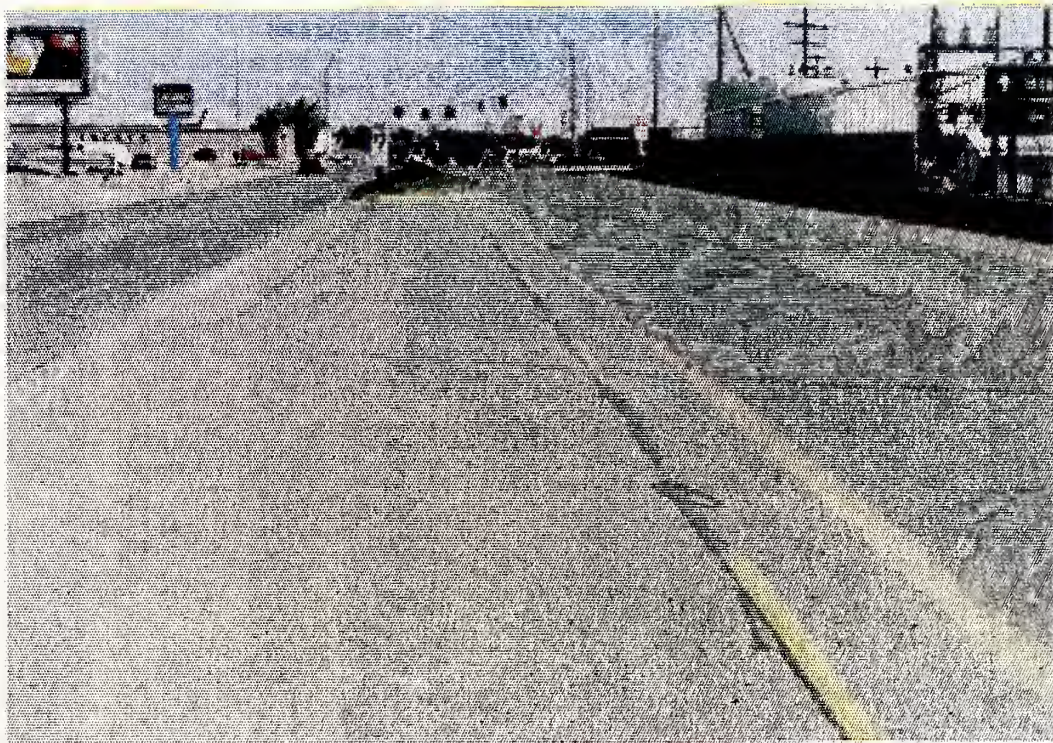
SITE 11: On Smelter Avenue opposite the "To U.S. 87 -" sign looking east. Notice the driveway spacing in the northwest quadrant of the intersection. (2/16)

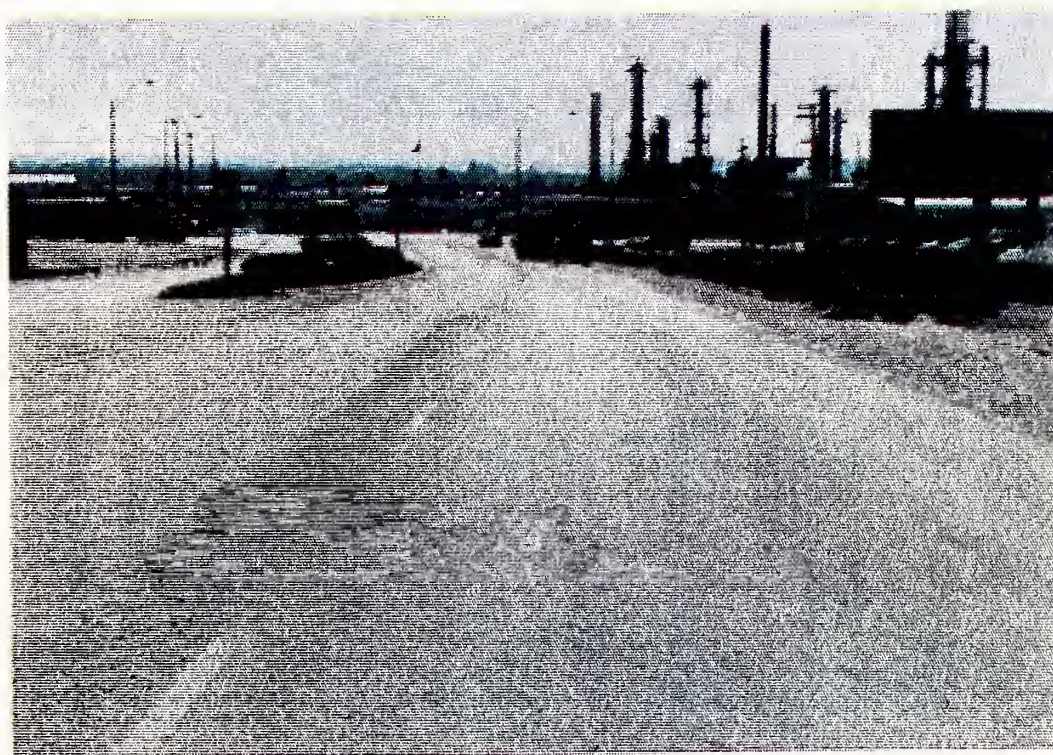
SITE 11: On 10th Street North approximately 150' north of the north end of the median looking south. Notice there is no roadway lighting between Smelter and 25th Avenue NE. (2/19)

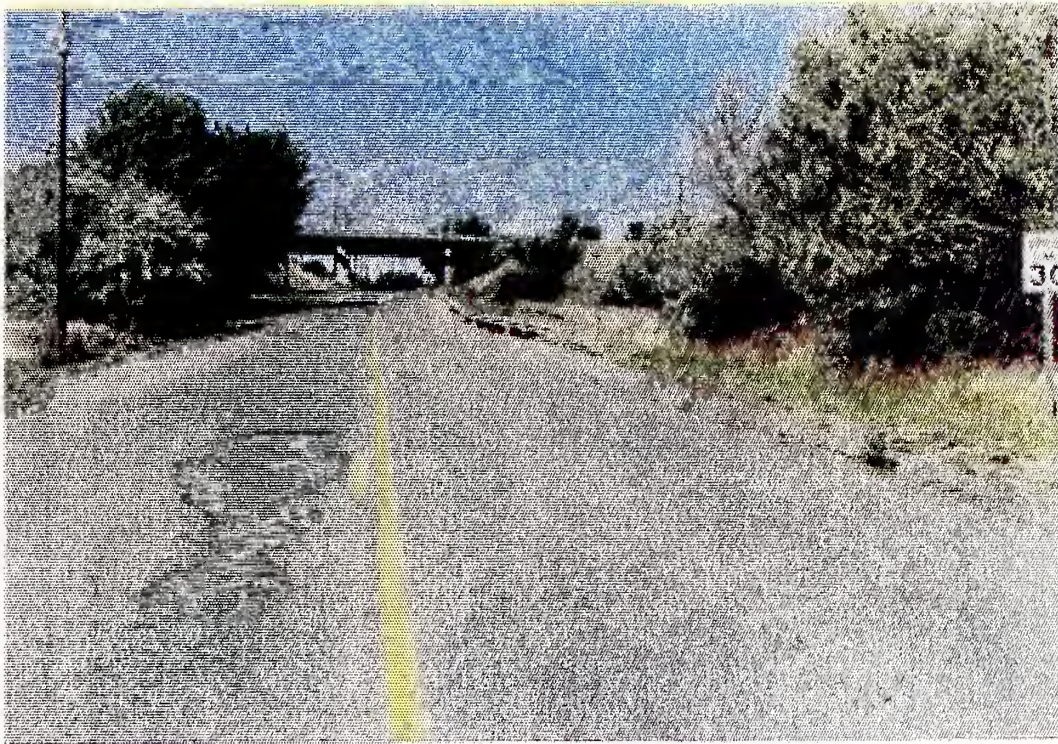
SITE 14: Flood Road approximately 500' south of 18th Avenue South looking north. A northbound no passing zone begins at this location. (4/14)
